Client: Kier/Canal River Trust

Sharpness South Pier is located downstream of the outer gates (sea gates) to Sharpness Tidal Basin. The pier is effectively located within the River Severn, at the point where the river meets the Gloucester & Sharpness Canal. The function of both north pier and south pier is to guide ships into the Tidal Basin from the River Severn. In June 2020 the MV Lady Adele (photo inset) on arrival at Sharpness Port contacted the South Pier at Sharpness. As a result of the vessel impact, the South Pier sustained damage which required urgent inspection as-well-as removal of seabed debris and loose elements that may become detached in the near future.

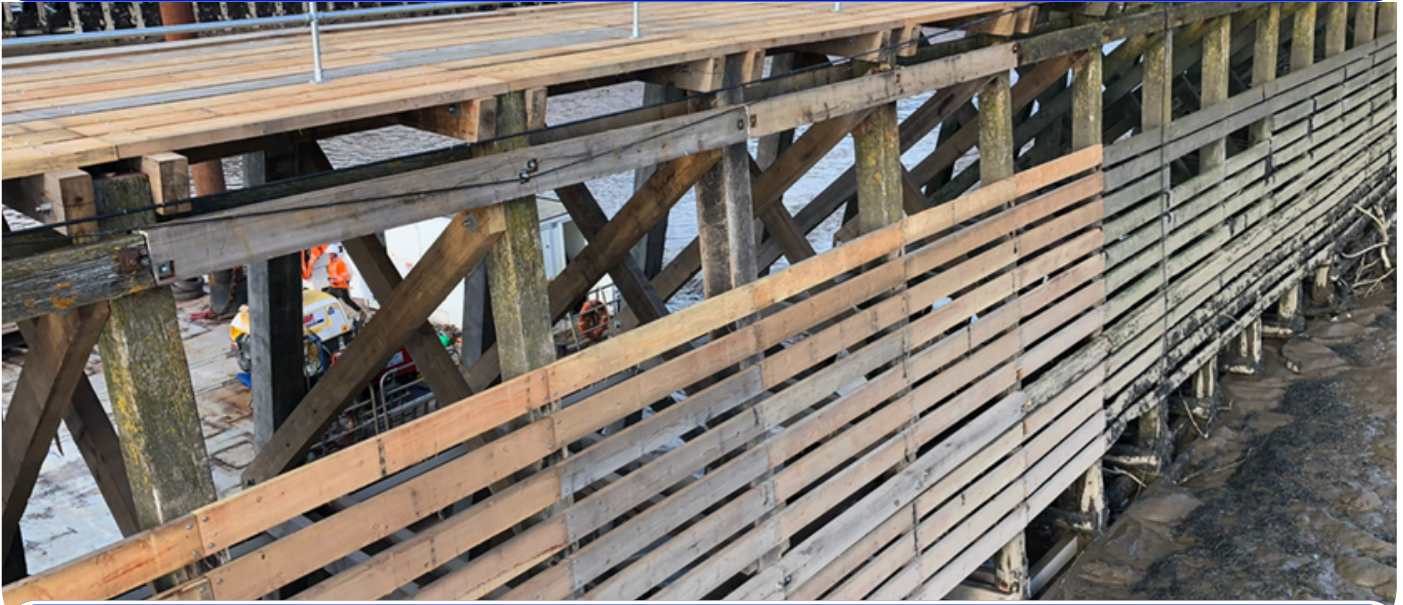
The timbers piles had been either snapped at the base or further up the structure therefore requiring replacement from their foundation up.

This involved installing new trestles with foundations drilled into the riverbed so that the damaged section could be rebuilt in the same format at the existing south pier.

Piles were sheered or chain sawed down, then pulled from their foundation sockets using the excavator aboard Maverick. Once removed the existing foundations would be broken out and removed allowing new timber piles to be installed.

Grout pumping was employed to safely tremie grout into the newly created pile sockets without allowing silt or grout lose into the water course.

The structure above was then rebuilt working up and down the tide using Maverick's crane and working vessels. The works were completed on programme and to an equal or higher standard than previously employed, client and statutory stakeholders expressed their gratitude for the prompt and professional service
