Client: Fort Bovisand Developments

Dec 2020 - Jan 2021

Project: Cliff Stabilisation

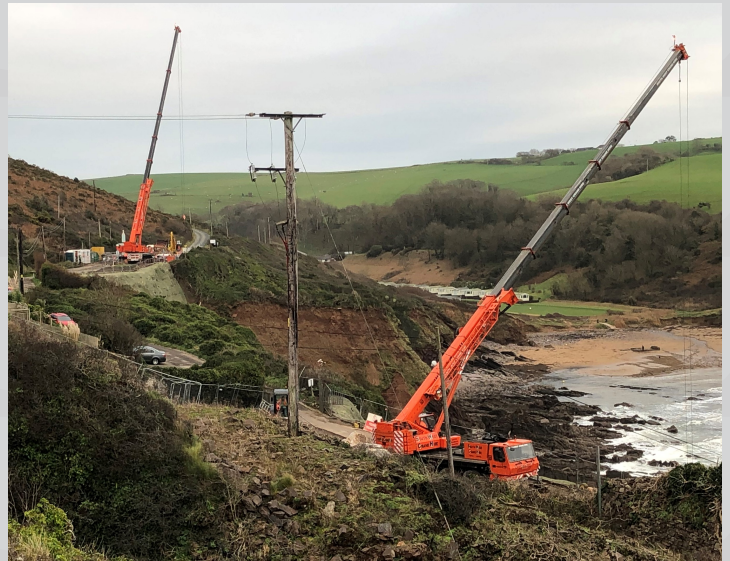
Due to the rocky foreshore, it was impossible to deliver materials or plant by sea. All works were therefore completed from above, using a combination of roped access techniques and heavy craneage to stabilise the cliffs. This required careful co-ordination with Red Rock Geoscience to ensure that the cliffs were sufficiently stable - in temporary state - to withstand the imposed crane loadings.

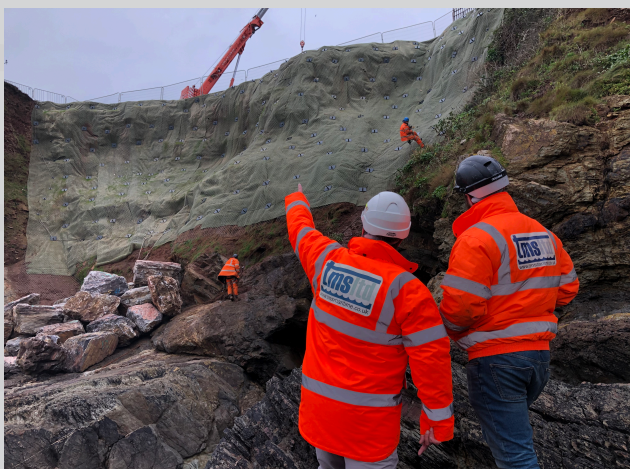
Three distinct gullies were repaired using various techniques. Firstly, a total of 1600t of rock armour made up of 3 to 4 tonne blocks was lowered by 120t crane into position, guided by roped-access technicians. The second gully, which had been stabilised historically by the construction of a masonry wall at beach level, required repairs. Primarily, reparations consisted of underpinning and re-pointing. Underpinning could only be completed by crane-lifting an excavator down onto the foreshore during each low tide, together with the required concrete. The re-pointing was completed by roped access. Finally, once the wall had been stabilised, a sink hole that had developed above it was then filled with 1100t of 6G stone.

In the final gully, a fissure and blowhole above it were plugged and sealed using specialist marine mortar and marine-grade concrete. This was again completed using roped access techniques. As a final measure, a 3D scan was completed in order to produce a georeferenced point cloud survey and geospatial model, to provide a baseline against which future movement of the cliff can be monitored.
