Client: Bournemouth Water

**Requirement:**

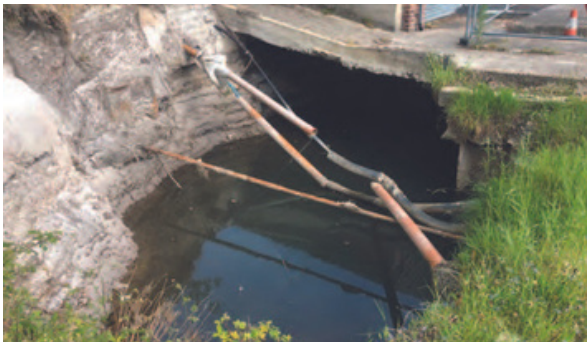
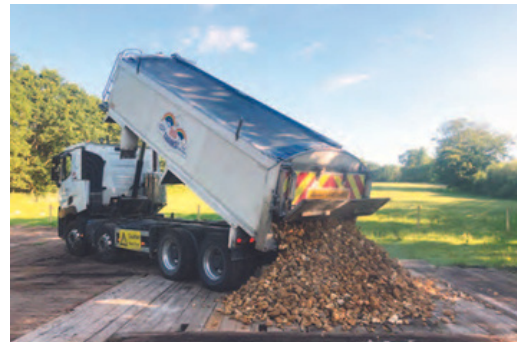
The raw water intake at Matchams is located on a fast flowing bend on the River Avon. The building was constructed C.1955 and provides a reliable source of raw water to the WTW in Bournemouth. Water depths are typically 3-5m with a high river flow rate, circa 3 knots, even when not in spate. Delivery requirements were to stabilise the existing riverbank and arresting the damaging scour whilst providing the least amount of environmental impact.

TMS were contracted in 2018 and 2020 to carry out an in-water visual inspection of the steel sheet pile wall as well as Cygnus Underwater Ultrasonic Thickness (UT) readings of the sheet piles. During the initial inspection in 2018, TMS observed some riverbank subsidence. Underwater examination revealed that there were several defective clutches and exposure below the sheet piles at riverbed level. This in turn had led to riverbank washout behind the sheet pile wall. By June 2020, the river water depth had increased along the most affected area by up to 1.2m, indicating riverbed scour.

To place the Salix AquaRockBags at the toe of the sheet piled wall, the rock bags were filled using a 21T excavator then the 70T crane lifted the bag up and over to the river. The divers, who were working from a jet float pontoon system being used as a temporary diving platform, then guided the 4T bags from the riverbed into the position as per the design drawings. The bags were secured/knitted together with a high quality tensile synthetic 20mm tiger rope.

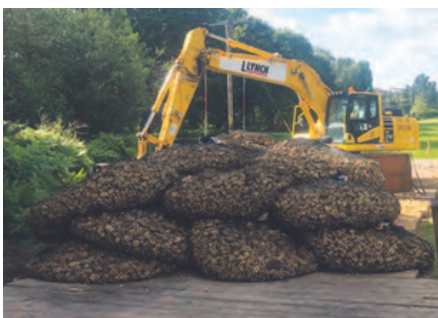
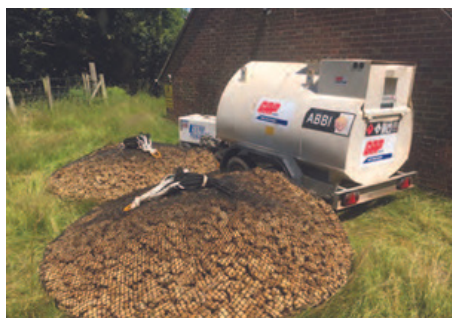
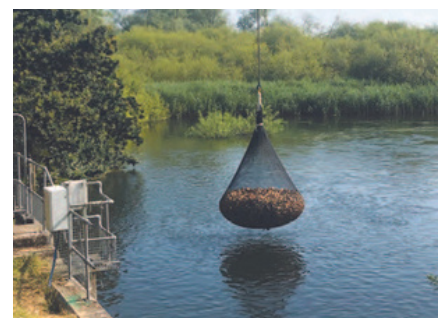
Despite working during the hottest two weeks of the year, with temperatures in the low 30s°, 120 bags were assembled and installed within 10 days, providing a long term protection to the water intake structure.
