Project Case Study

Client: Bam Nuttall
Project: Isle of Man Sea Terminal

Value: £1.5M Duration: 9 Months

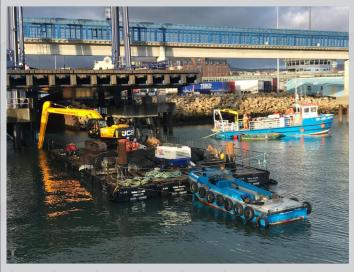
The fender pile at the end of the pier had already been removed, TMS were therefore required to socket the new pile into the original pile. Firstly, the pile stub that remained had to be cut using BROCCO (underwater cutting equipment) below the remaining damaged part of the pile where the pile had been bent over; to allow enough circular room for the new pile to be fitted. The internal area of the pile stub was then excavated to a depth of 1.3m below seabed, once secure the pile was pumped full of concrete which allowed the fender pile sleeve to be installed over the pile for the fender panel installation.
